July 6, 2010

Mark Smith
City of Minneapolis
218 North Rock Street
Minneapolis, KS 67467

As you requested, per referred by the Kansas Department of Health and Environment (KDHE), I conducted a sludge profile of your wastewater stabilization ponds on June 29, 2010. A report is enclosed. I have also enclosed a previous KRWA sludge profile and smoke testing report.

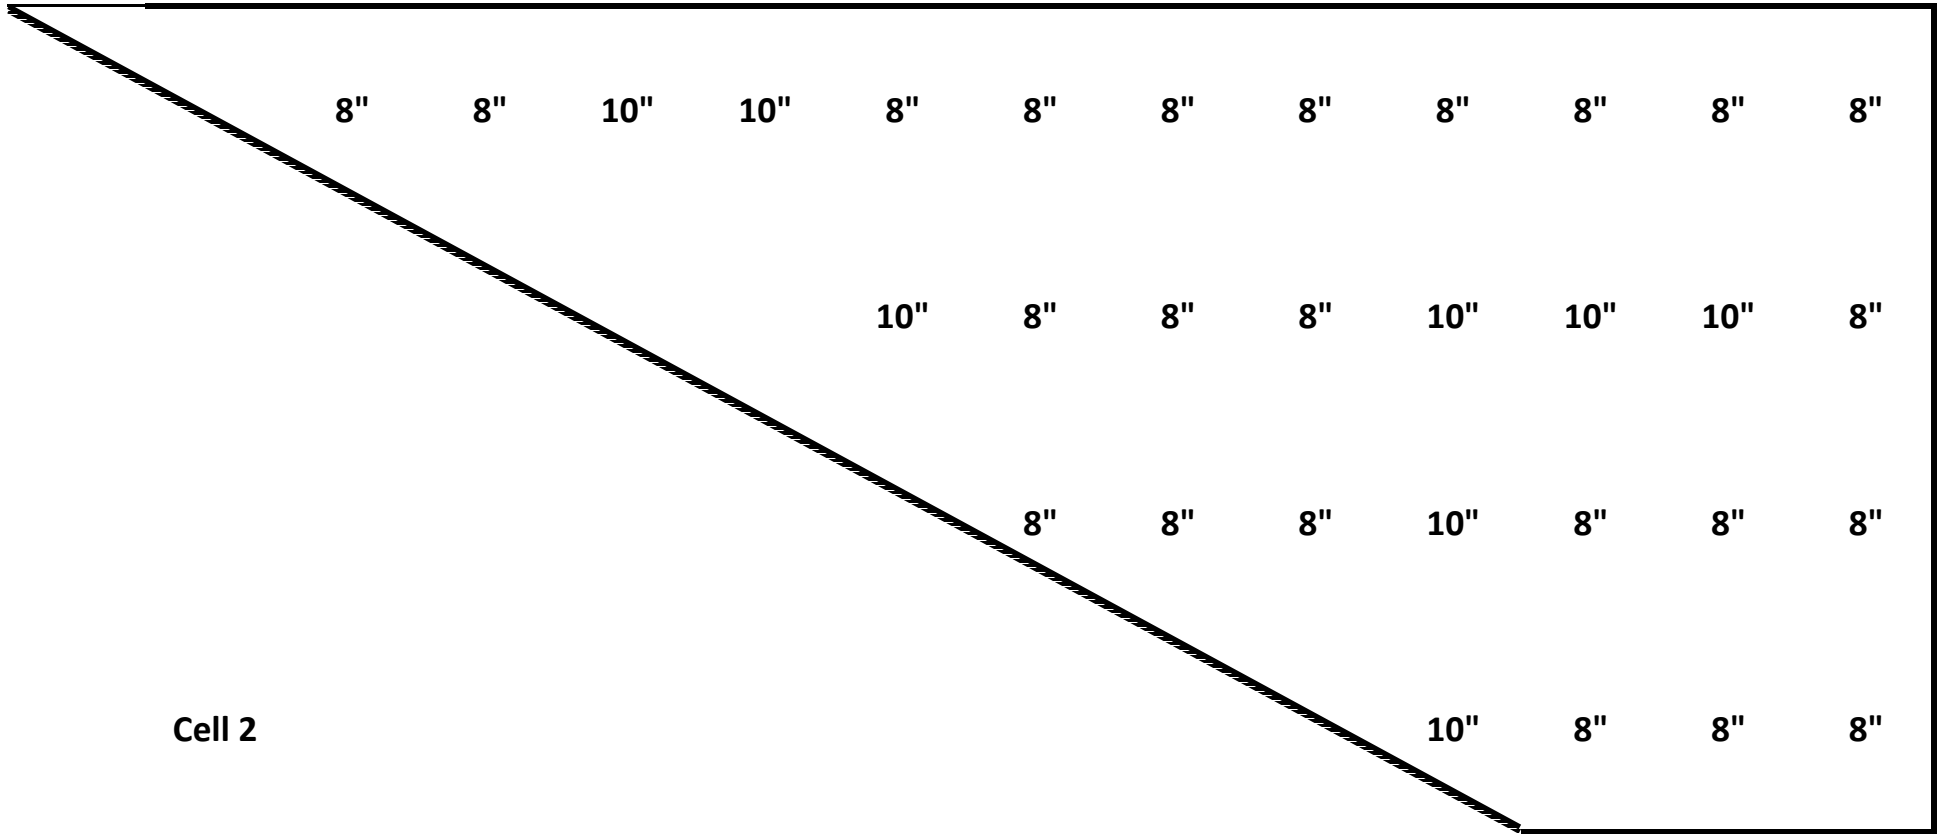
In Cell #2, we took 31 measurements. The average sludge depth in this cell was 8.5 inches, with 6 inches of heavy sludge. This cell was being operated at a depth of 5.3 feet. The loss of capacity in this cell was 13.28 percent.

We took 36 measurements in Cell #3. The average sludge depth in this cell was 8.33 inches. This cell was also being operated at 5.3 feet of depth. The loss of capacity due to sludge accumulation was 13.01 percent.
