Loss of Chlorine Residual Leads To a Much Deeper Issue at Inman, Kansas

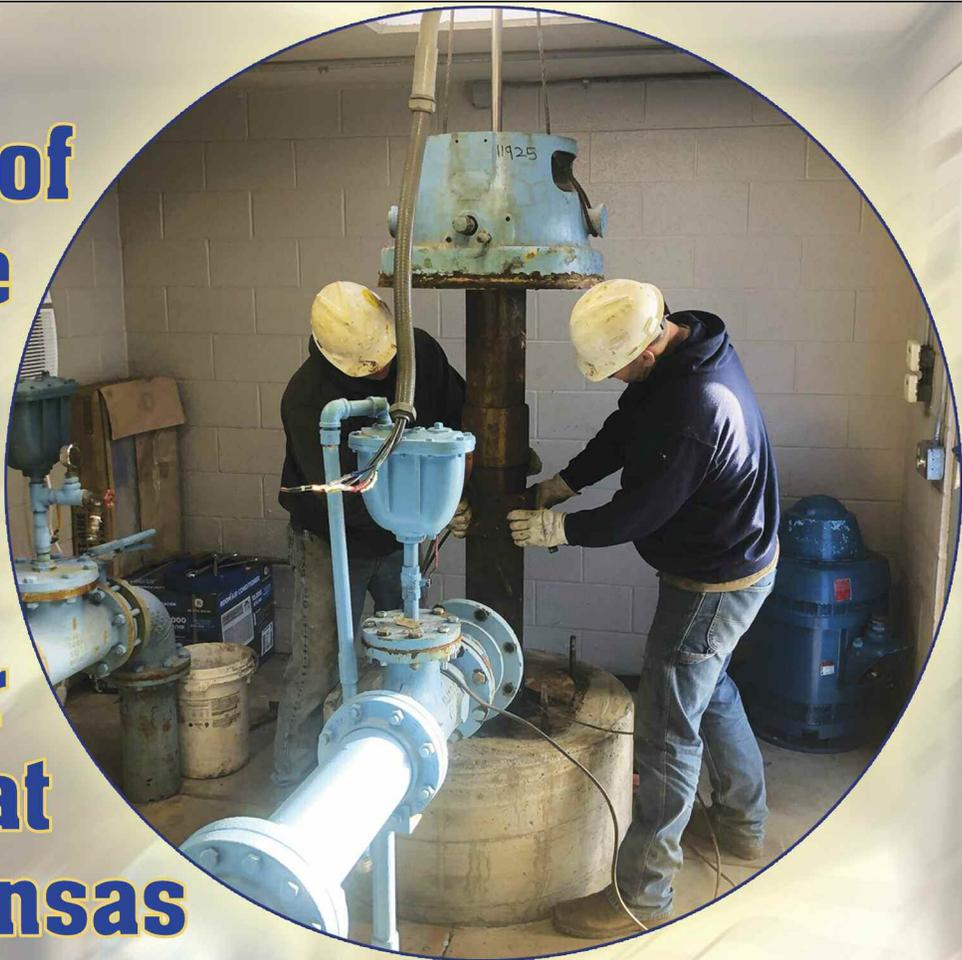
Darren and Dallas Alexander prepare to remove the first section of column pipe from the discharge head.

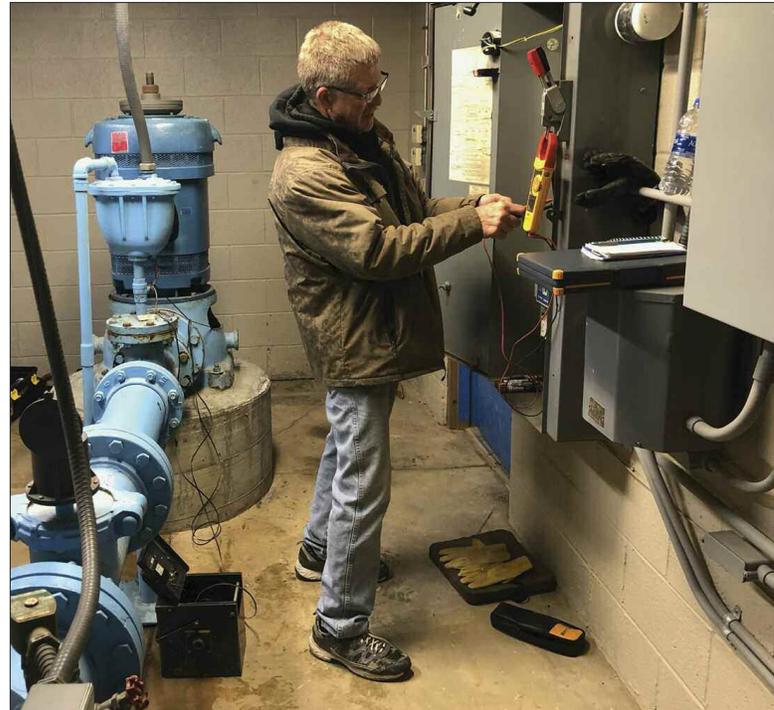
KRWA Circuit Rider Jon Steele tests well performance and electrical system at Inman.

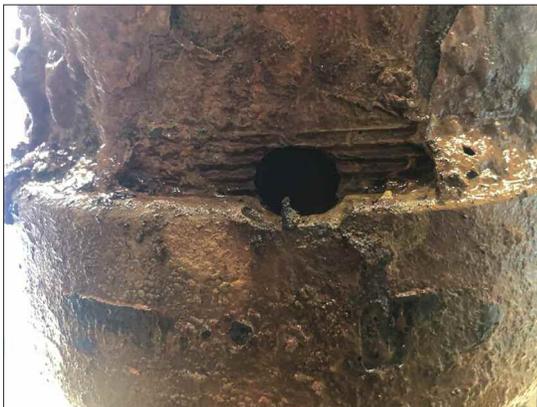
Problem found – a .75-inch hole in the column pipe.

After conducting the pumping water level portion of the well performance test, we noticed the cable was wet way above the static water level where there should have been no water. Answers to the problem were now coming into focus. This was a good indicator that the problem was most likely due to turbulence from a hole in the discharge pipe and high pressure water spraying against the side of the well screen. In fact, that is what the problem turned out to be. There was a .75-inch diameter hole directly above the pump and water was spraying out against the side of the well, dislodging the gravel pack, forcing gravel through the slots in the screen.

Going back to the call for technical assistance at Inman, I recommended to Superintendent Boeger that the well be taken out of service until the pump could be pulled, and the

discharge pipe and the line shaft be inspected. I also recommended a down-hole inspection of the well casing and screen. The city agreed to those suggestions.

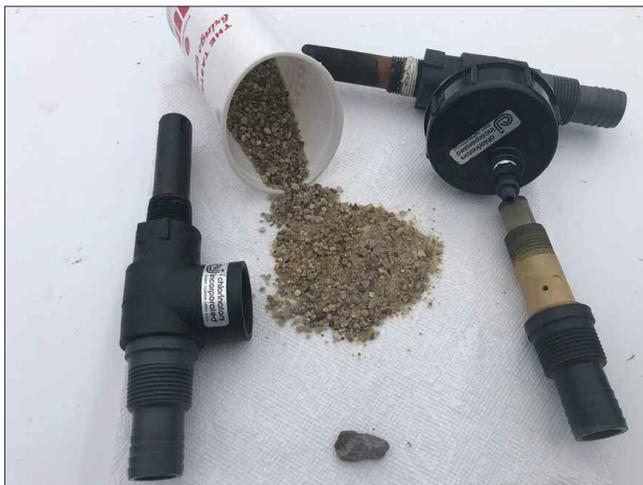
Upon disassembly I noticed a small piece of debris partially plugging the ejector nozzle, blocking the water flow. This small nozzle hole is the very heart of the system. It is actually a safety feature by design: lose vacuum and the system loses chlorine gas feed.

The next logical step was to flush the strainer screen; we then reconnected the tubing. It immediately plugged again. This caused Rod and I to consider a more serious problem. We removed the Y strainer completely and took it back to the shop for disassembly as it required more tools than we had on site. After we removed the stainless steel screen we noticed it was packed completely full of gravel.

This answered the question as to what happened to the booster pump and why it wore prematurely. Water Well Pumps are not designed to pump sand and gravel. Now the question is what is going on in the well. In my mind, there were three possible issues:

This photo shows the chlorine ejector and gravel that was removed from the Y strainer.

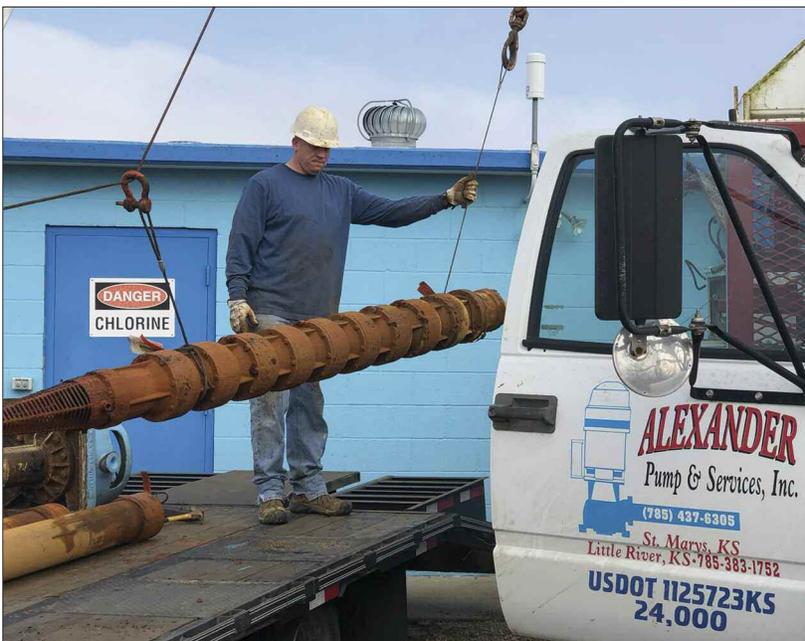
The 9-stage pump is lowered to the work trailer.
