Save that well before it collapses

Doug Guenther
Tech Assistant

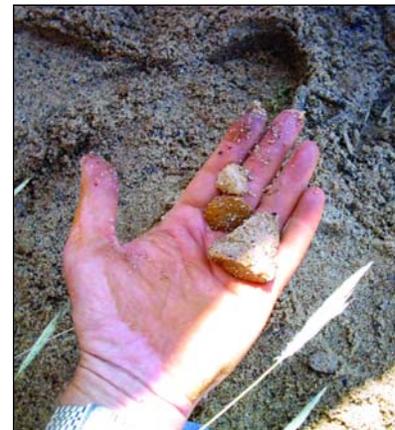
Sand, silt and large aggregates had entered the well through holes in a failing casing.

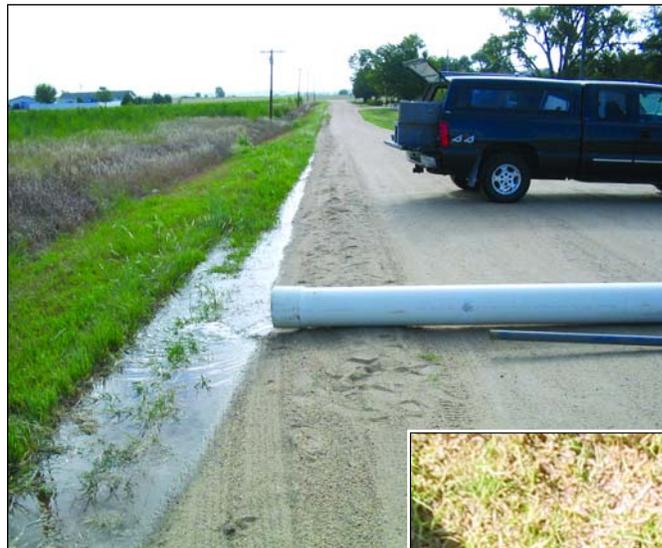
Left: Silt, sand and chlorine being flushed from the Dorrance well. The sand was observed when the well was shocked in order to remove iron bacteria.

Below: A bacteria colony resides on the pump pulled from the well.
