## Leak detection – rewarding but can be very contentious

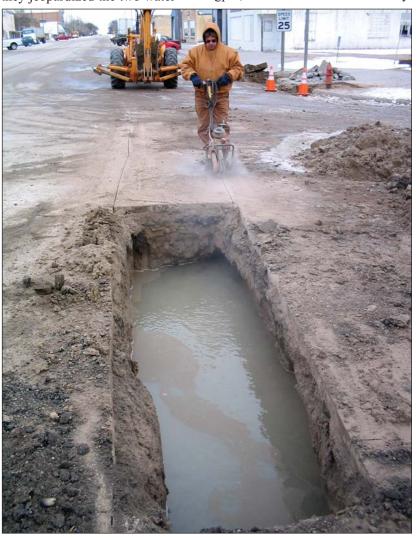
Grainfield City Council Member Joe Heier uses a concrete saw to make way for the backhoe to finish excavating the water main leak on the state highway and main street of Grainfield in January, 2008. The elusive leak caused concern with KDOT workers who saw the highway slowly develop a 20 yard patch.

The second system to call with similar water loss, low pressure problems was Grainfield. I detected the sound of escaping water near Front and Main Street using the 'contact method', touching hydrants, meters and valves in the immediate vicinity. Further investigation revealed that a leak of about 70 gpm was flowing into a storm drain. The city contacted the Kansas Dept. of Transportation (KDOT) as the leak was on a state highway and also the phone company for locates. The phone company tech was gracious enough to also locate the water main. The suspect area of 4-inch cast iron main was about 80 yards long; KDOT wanted the excavation to be kept at a minimum. Of course, so did everyone else. We listened to the area with the ground mic. This indicated that the leak was near the fire hydrant about forty yards north of where the water was pouring into the storm drain. But the leak was not on that section. Eventually, we located the leak approximately 20 yards north of the storm drain; it was repaired and the system was back to full restoration.

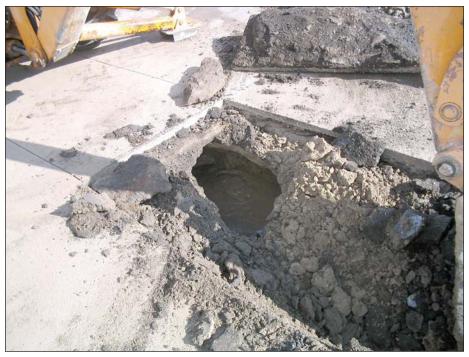
The end of the 20 plus yard-long trench is shown above. The point of the leak is seen with the water bubbling up in the hole. The crews covered the trench as they moved north so the main wouldn't freeze behind them. The frozen ground and type of soil kept the ground mic from pin pointing the leak exactly. The leak was found half way between the fire hydrant where it was first heard on the mic and the storm drain where it was heard draining into.
