# Rural Water District No. 6, Franklin County, Weathers the Storm

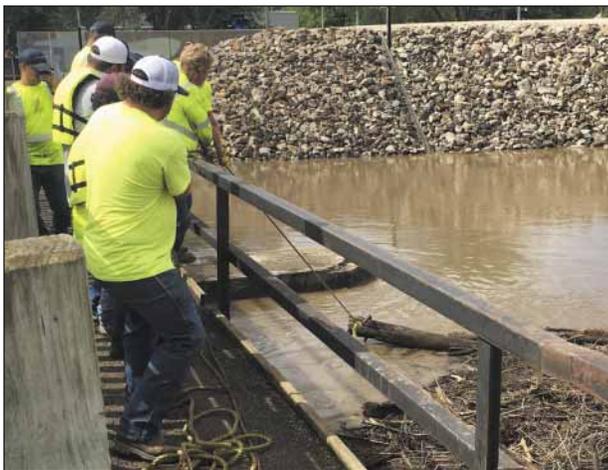
City of Ottawa employees use a hook and rope to dislodge tree debris from the upstream side of the Prairie Spirit Rail Trail bridge over the Marais des Cygnes River.

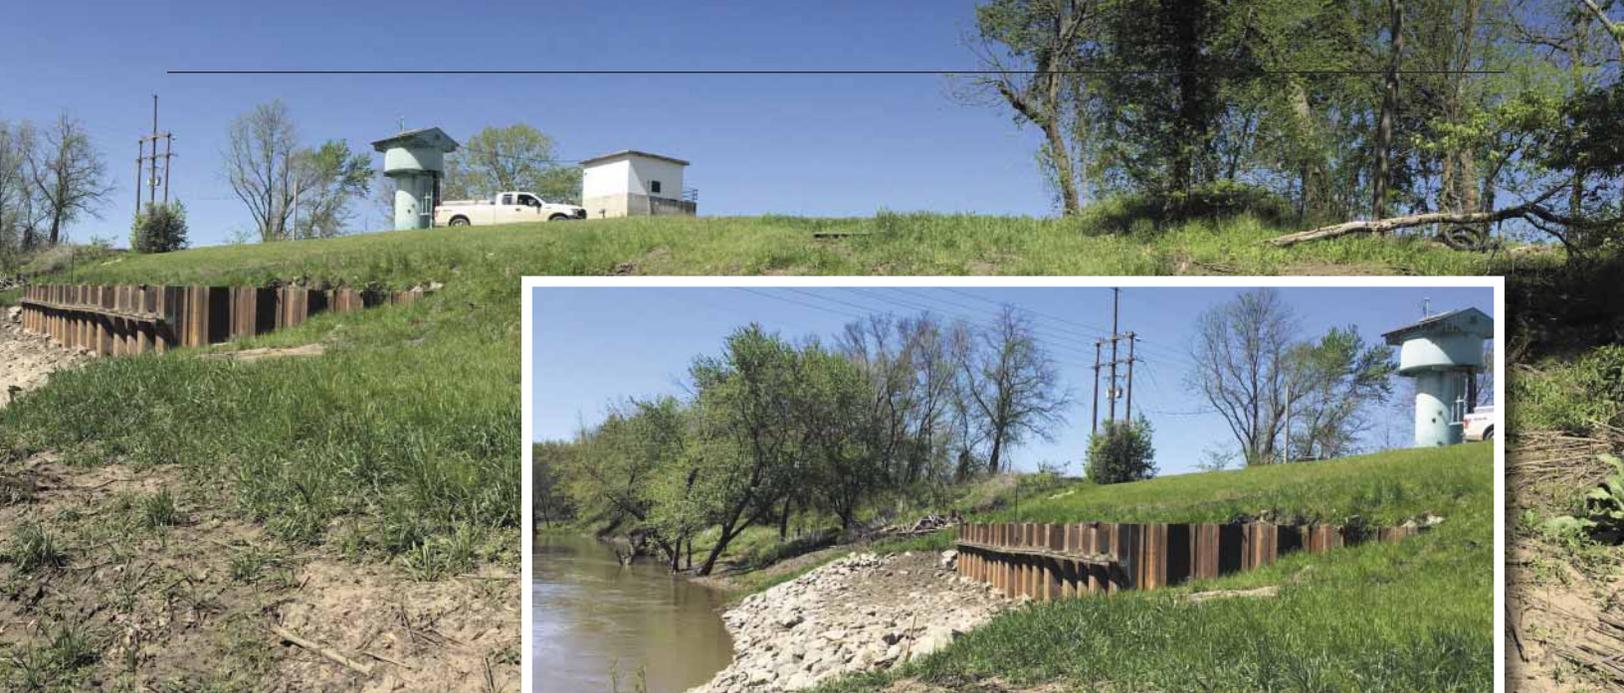
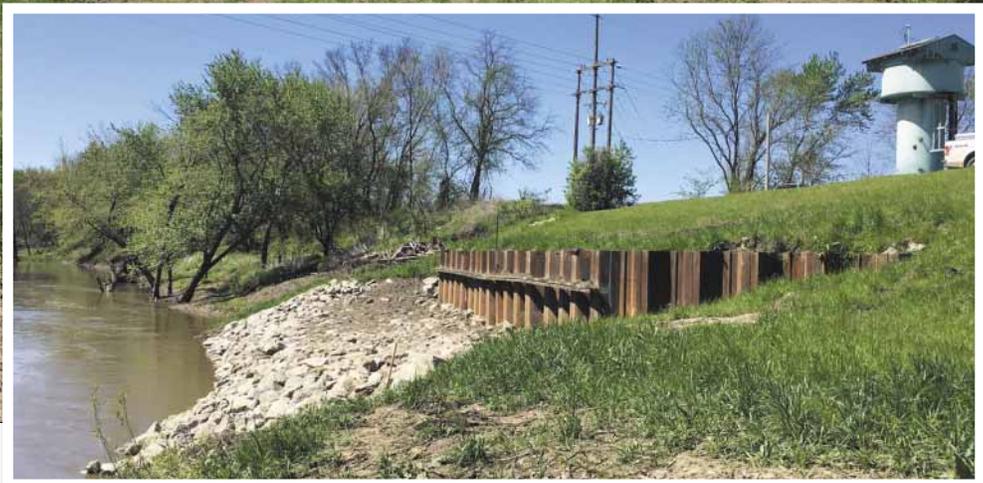
Looking south (downstream) one can see the boulder-sized rip rap that protects the lower levels of the stream bank. Further up from the bank is the sheet piling which allows two different levels of 4:1 slopes. Water levels have risen a few times in the last nine months, enough to cover the rip rap and deposit silt in the crevices of the boulders. The intake tower is located on the far right on the top of the riverbank.

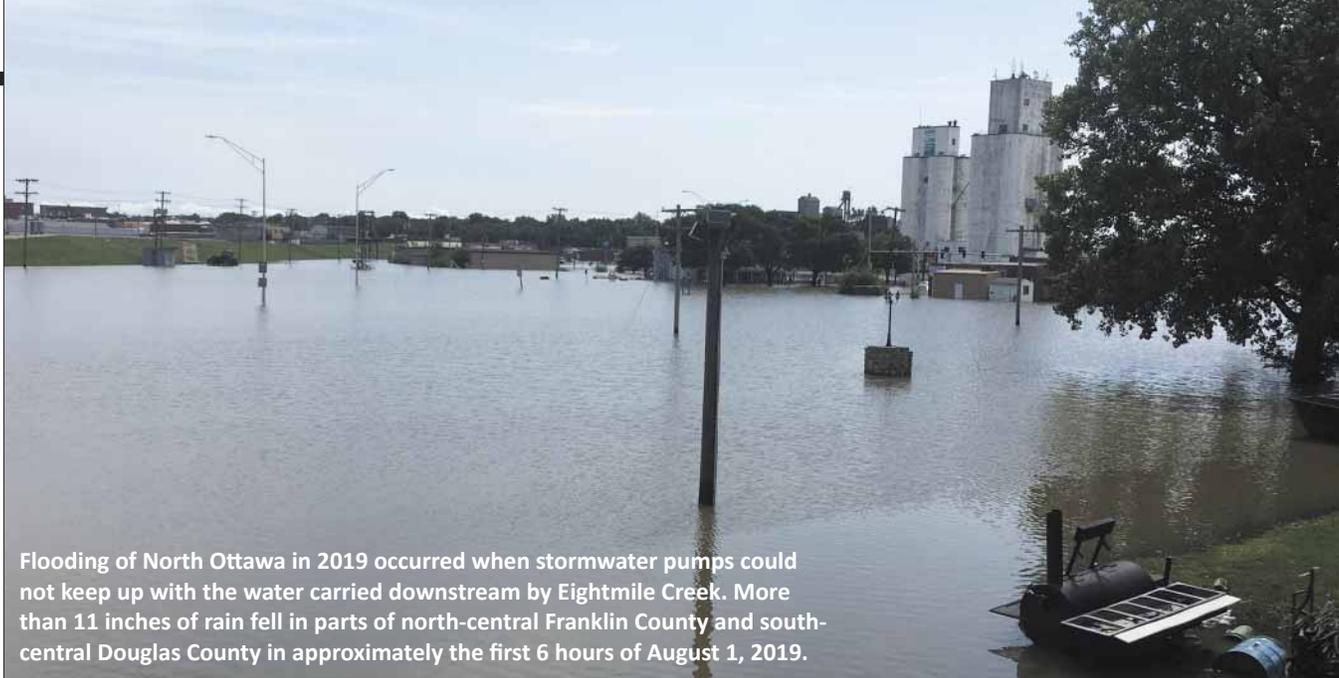
Flooding of North Ottawa in 2019 occurred when stormwater pumps could not keep up with the water carried downstream by Eightmile Creek. More than 11 inches of rain fell in parts of north-central Franklin County and south-central Douglas County in approximately the first 6 hours of August 1, 2019.

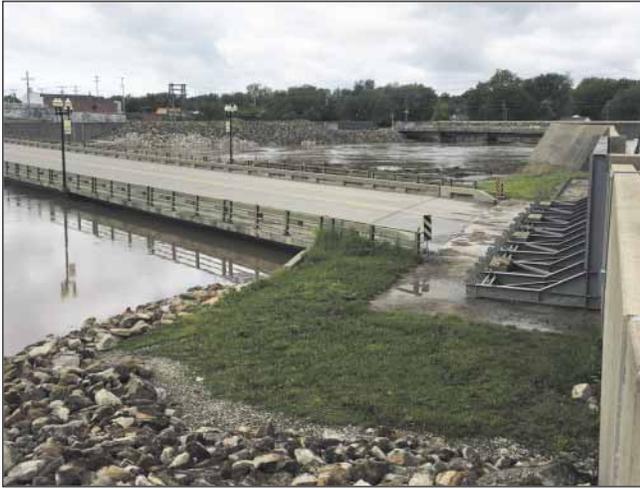
**On May 17, 2021, the Marais des Cygnes River reached flood stage again. On May 18, the gates on both ends of Old Highway 59 / Main Street remained closed to keep flood water inside the levees. Rain remains in the forecast for the next few days.**

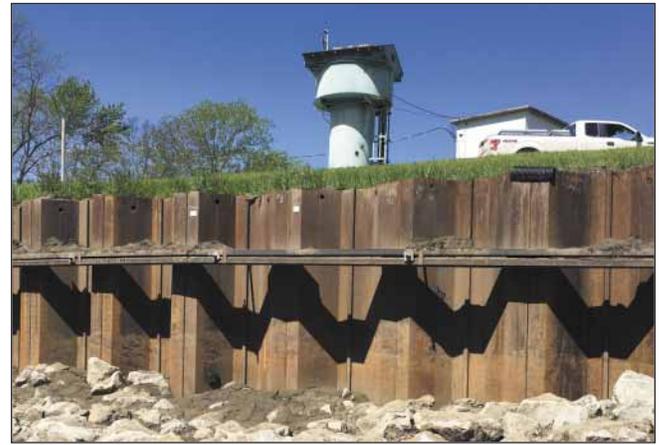
**The exposed sheetpiling in the foreground is approximately 8 feet high. Running across the front of the piling is part of the anchoring system with connects the piling to the concrete deadman buried behind the piling. The intake tower is in the background.**

Near the river’s edge at normal flow, a rock toe was installed parallel to the edge of the river, to anchor the riverbank from further rotational slumping. Approximately 50 to 60 feet from the river’s edge (and farther away at the ends), 25-foot long sheet pilings were driven into the bank to allow the bank slope and elevation to be reduced by excavation. These interlocking sheets of steel were driven to an

elevation of 831 feet, except for the piling that was directly over the intake pipe and air line, which was only driven to approximately 835 feet to prevent possible damage to the important infrastructure below. After excavating the streambank to a 4:1 slope on the river side of the piling, a geotextile fabric was laid on the surface and large 18-inch diameter boulders were installed to prevent further erosion. On the bank behind the piling, an 80-foot long concrete deadman anchor two feet wide by four feet deep was installed. Each sheet of piling was anchored to the deadman. The land on the opposite side of the piling was backfilled with the excavated material to create a new
