City of Courtland Makes Lagoon Improvements

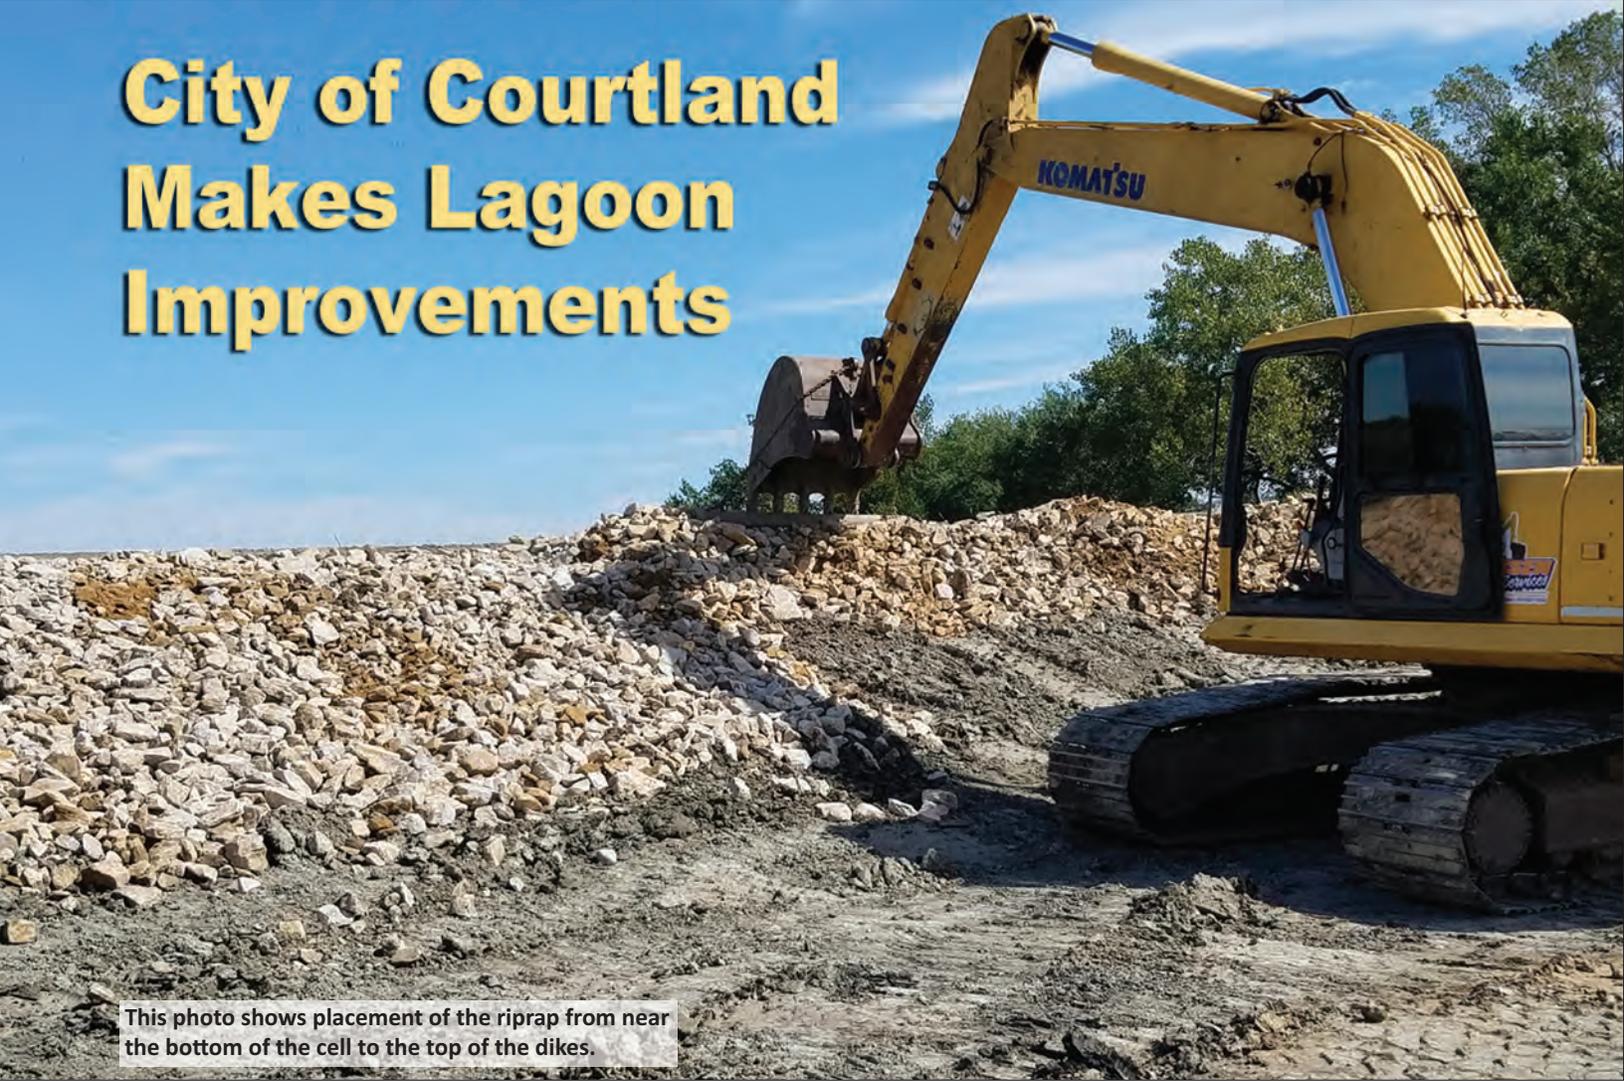
This photo shows placement of the riprap from near the bottom of the cell to the top of the dikes.

It was very apparent that the dikes on Courtland's three cells all had suffered severe erosion. We discussed reshaping the dikes to the proper slope and then to add rock or crushed concrete riprap to control erosion. Riprap should be two- to five-inch diameter material. This is a minimum design standard. That size of riprap is large enough to prevent the riprap from washing into the cells, but small enough to prevent animals from burrowing into dikes where rip rap has been placed. My suggestion is if a wastewater system in your area has done a similar project, contact them for information as to cost, who their contractor was and where to locate the riprap.

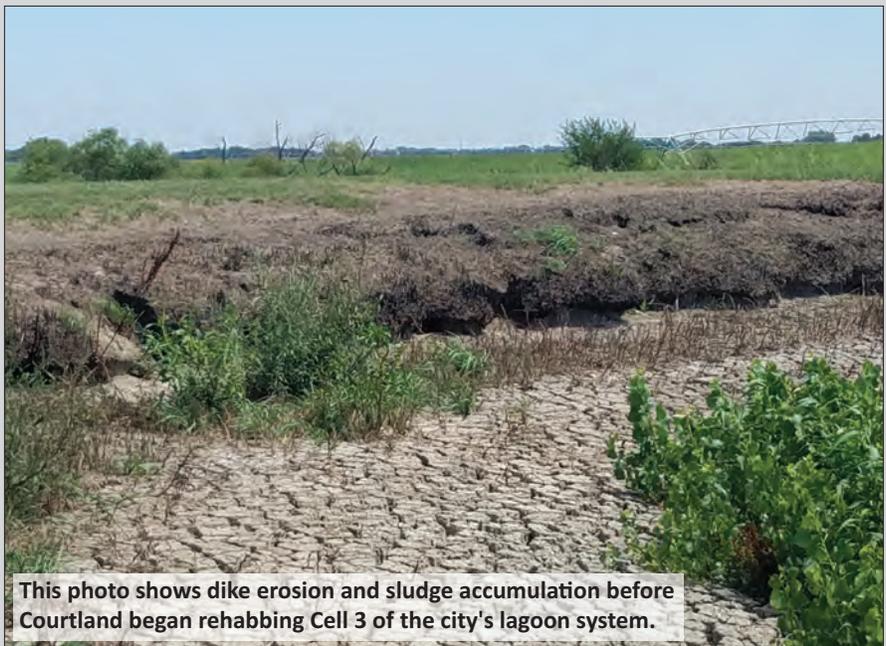
This photo shows dike erosion and sludge accumulation before Courtland began rehabbing Cell 3 of the city's lagoon system.

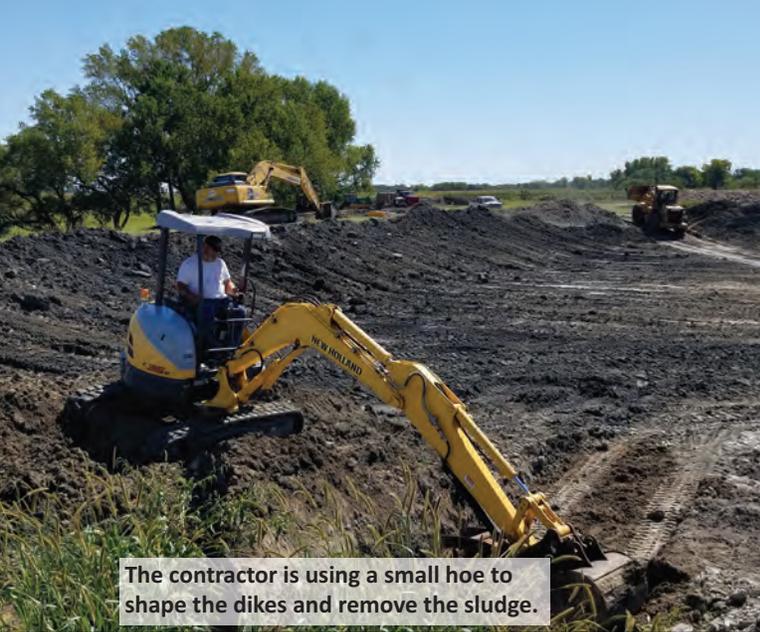
The contractor is using a small hoe to shape the dikes and remove the sludge.

time. The city contacted a local contractor for cost estimates. It was decided to repair one cell per year, starting in 2016. The city provided the supplies such as the riprap and valves. The contractor was to remove the sludge and reshape the dike walls, and repair or replace valves.

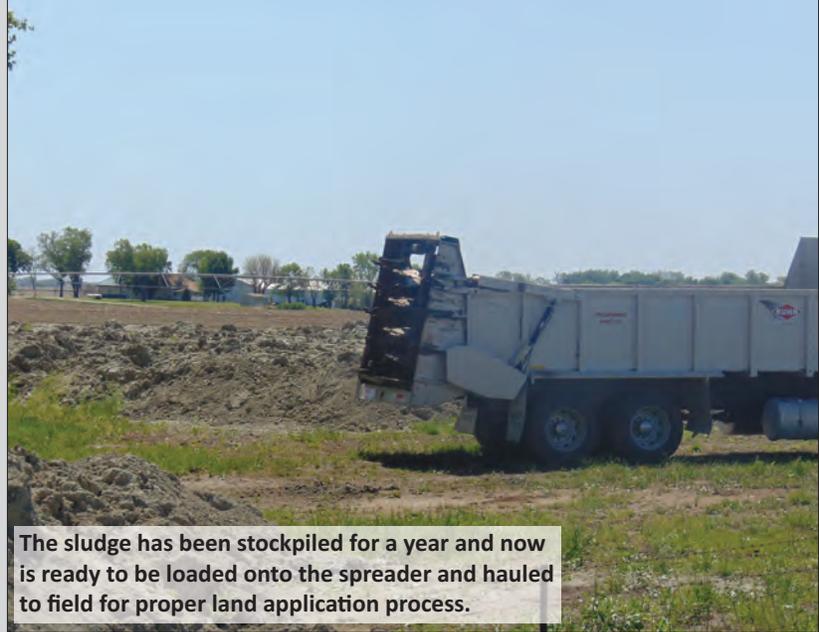
The sludge has been stockpiled for a year and now is ready to be loaded onto the spreader and hauled to field for proper land application process.

application rules. Information concerning land application of the sludge was provided to the city. The landowner, who had his own agronomist, calculated the agronomic rate for the crop to which the sludge was to be applied. The landowner applied the sludge with his equipment and the city monitored the application to ensure proper rates were followed.

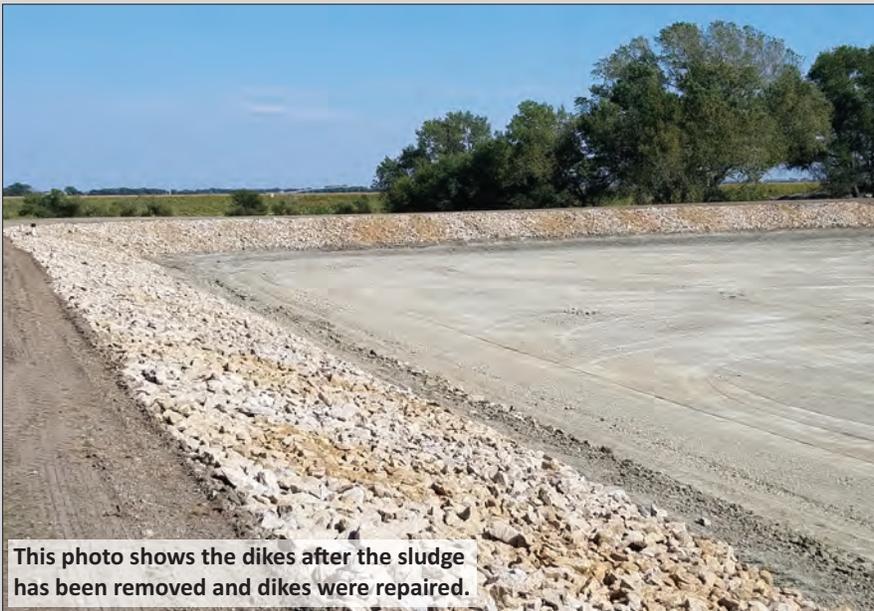
This photo shows the dikes after the sludge has been removed and dikes were repaired.

service and the city would be operating on only two cells. Cell 3 was slowly drained over the next month; the final water was pumped out. It took several months for the sludge to dry enough for the contractor to get into the cell to remove the sludge, reshape the dikes, add the needed valves and riprap the dikes for erosion protection. This process took about a month to complete starting in August 2016. Once completed, the cell was put back in service and the system was again operated in series.
