# The Question of Water System Viability and Sustainability

This article is about a very small water district that was formed at Corbin, Kansas following a discovery of groundwater contamination of private wells with carbon tetrachloride, a common pesticide used in grain storage in the 50s and 60s.

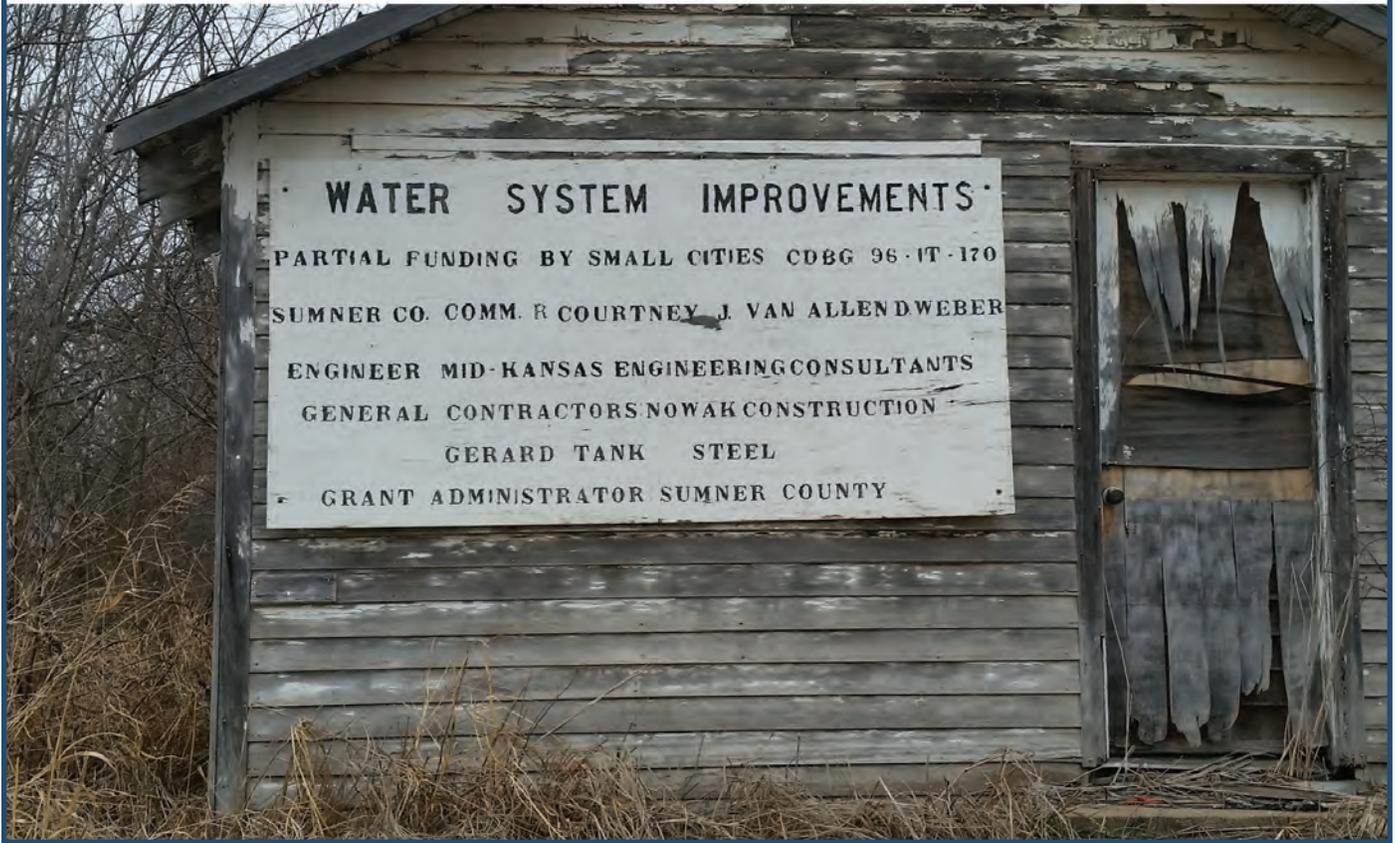
The water system in Corbin, Kansas was installed in 1996 with grant funds as a Superfund project due to groundwater contamination. The project which cost \$5 million today has only 10 customers and struggles to have adequate funds for operations and maintenance. The photo above is of the project sign that remains on the side of an old building in town.

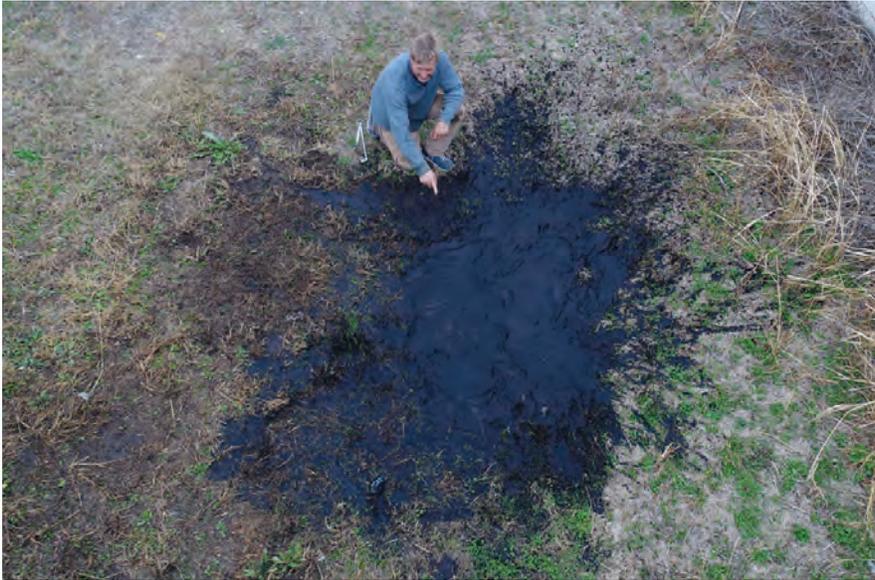
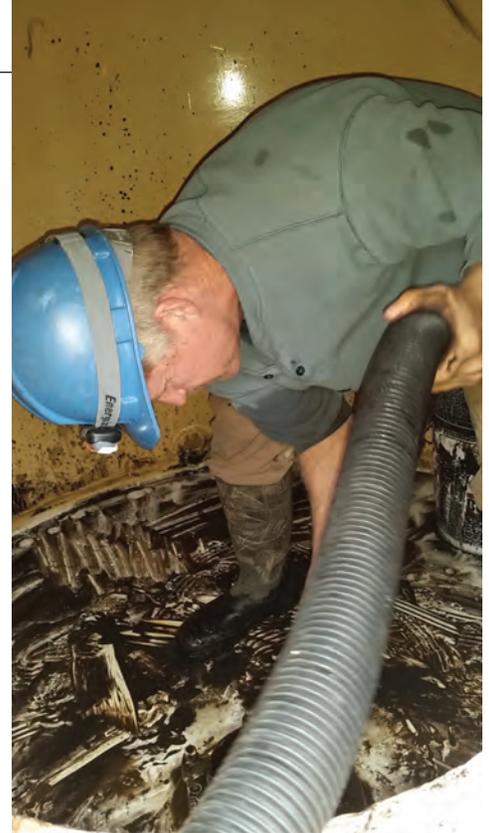
**KRWA Tech Assistant Jon Steele points to the manganese and iron deposits that were removed from the water storage standpipe. The tank had not been cleaned since the system was constructed. In the photo at right, Steele is vacuuming the deposits from the tank.**

In the case of Sumner RWD 7 at Corbin, the control system with VFDs did not exist and there was no money to install this type of system. So we used a pressure relief valve installed on a flush hydrant at the end of the system and allowed one small pump to operate continuously with the tank isolated from the system through a gate valve. Once the tank was opened, we found a four-inch layer of black muck at the bottom of the tank. Knowing the water quality of the water along the river basin where Caldwell's supply is located I was pretty sure that is what would be found. It was precipitated iron and manganese in the bottom of the tank and it resembled crude oil in color.

After the tank was thoroughly cleaned and washed down with a 200 mg/l chlorine solution, we closed it and filled the tank. It was allowed to fill overnight and overflow, until a sample could be collected the following day. The tank was

kept isolated from the system by maintaining the positive pressure and allowing it to overflow until the results of the bacteriological test were known. Once the lab results were reported as negative, the pumps were switched back to normal and the tank was placed into service. The district chairman/manager reports now that the chlorine residuals are better and much easier to maintain after the cleaning process.

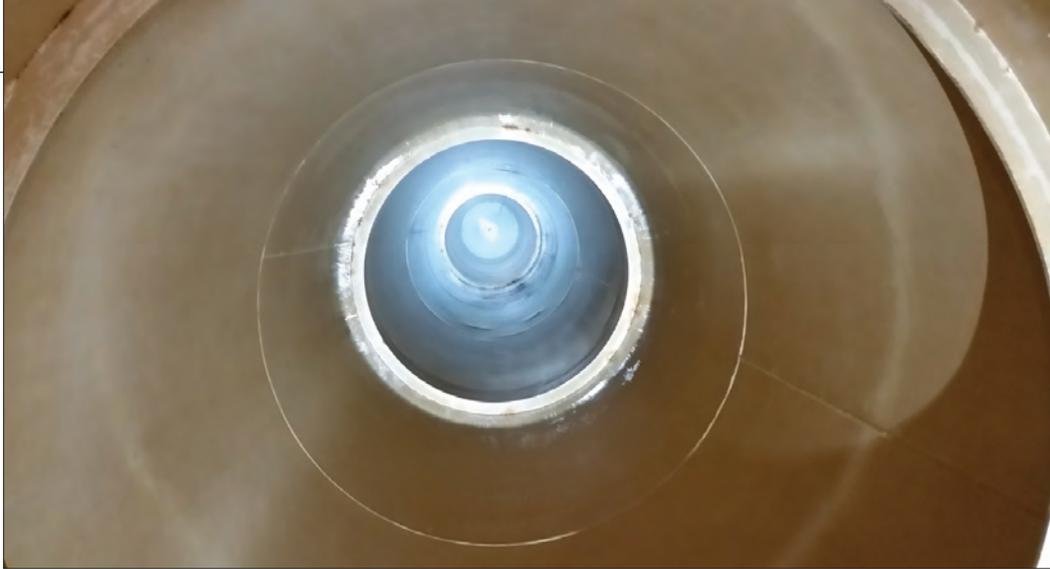
This photo was taken from the top of the storage tank following cleaning. The tank is in remarkable condition even after 20 years of service and no maintenance having been done.

simpler design which in my opinion would have reduced the initial costs and the operational costs. The design unnecessarily complicates the routine operation and maintenance of the system. The system has required only minor repairs until now but after 20 years even a well constructed system is going to show its age and start to need more extensive work such as tank sandblasting and recoating.
