WATER LOSS ISSUES IMPACTED BY CONDITIONS AND PIPE MATERIALS

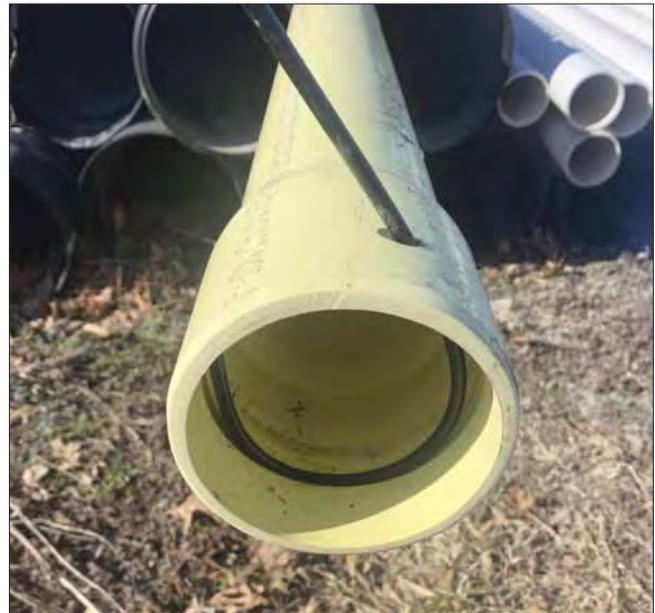
The Yelomine pipe incorporates a locking self-restraining joint which has grooves that allow a spline to be inserted to create a restrained joint that locks the pipe and coupling together.

Another type of pipe is called yelomine. This style of pipe has a restraining pipe system along with gaskets and an O-ring coupling which provides a hydraulic pressure seal. A spline is inserted at the coupling which locks the pipe and bell/coupling together. Yelomine is commonly used when installing road and creek crossings by boring. Once the bore is complete the pipe can be pulled back through the bored opening. This type of pipe can also be dismantled by removing the flexible splines.

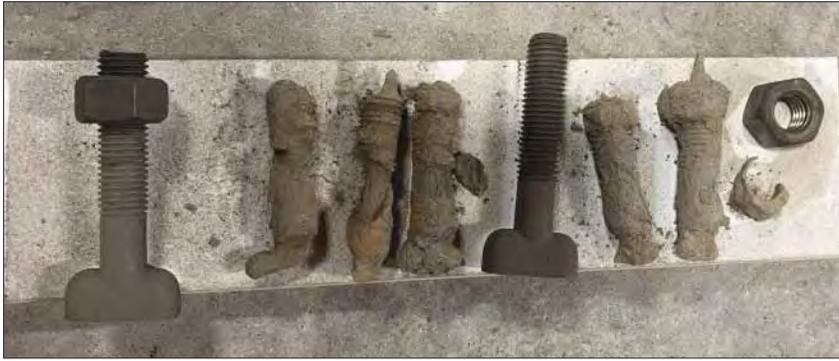
These repair clamp bolts were very corroded after being in the ground for only three years in a small city in northeast Kansas.

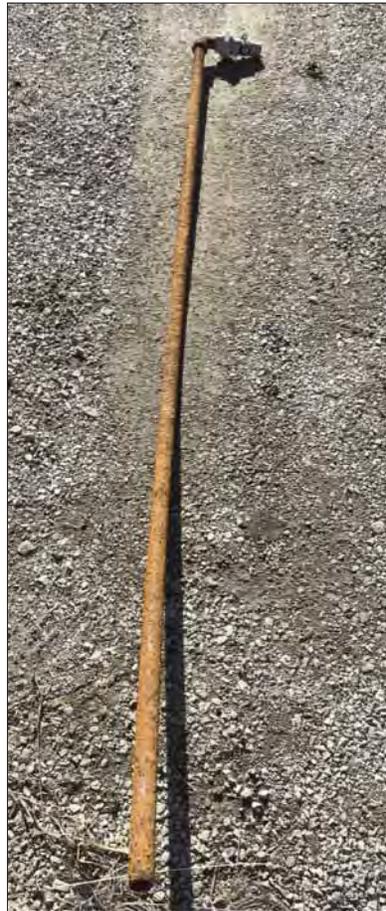
This section of steel service line is very corroded due to soil conditions. It is from a small municipal water system in northeast Kansas.
