Montgomery County RWD 11 addresses loss of chlorine residual

Montgomery County RWD 11 serves customers in an area north of Coffeyville. The district has taken a number of steps recently to improve the quality of water for its patrons.

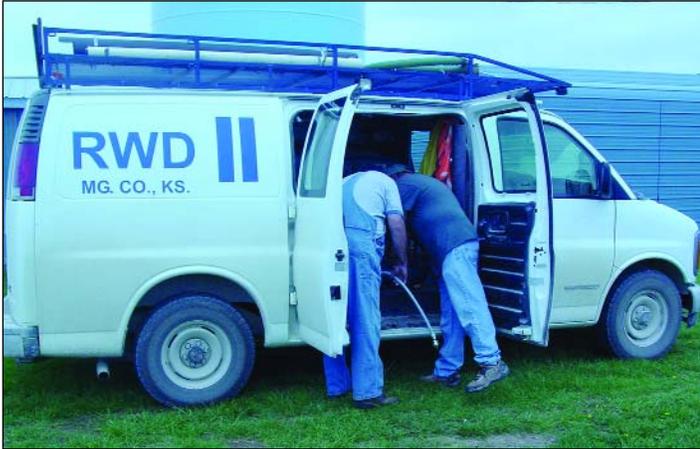
Operators Bob Voelzke and Tom Pauzauskie utilize the district van to work on a small chlorine booster pump. The operators both agree that the work the district has done has been a great help in improving chlorine residuals throughout the system and allowed time for other projects.
