Helping Camp Lakeside with water quality issues – what a great summer experience!

Jon Steele,
Tech Assistant

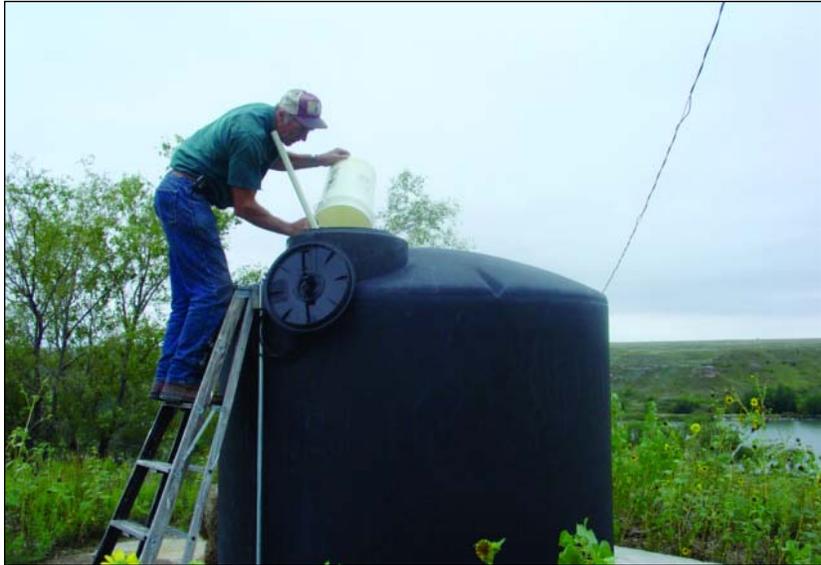
Lake Scott Park Supt. Reed Rolfs adds chlorine to the Camp Lakeside black poly ground storage tank.

a hill where the system's 2,100-gallon poly storage tank is located. The original riveted steel tank was replaced by a wooden tank which was in service until a couple of years ago when they installed the current poly tank. The tank is a black, opaque poly

material to keep sunlight from penetrating. If sunlight penetrated the tank, algae could form creating water quality problems. Almost all water contains some nutrients. An ideal environment for algae growth exists when the nutrients are exposed to sunlight

An inspection of the tank revealed fluffy material swirling around inside when the pump was running. It was difficult to tell exactly what the material was, looking in through the top of the tank with a flashlight. We left to get the necessary items to drain and clean the tank. After returning back to the camp, we noticed that the water from the hydrant we were using to fill the portable tanks had a greenish brown tint. I was a little puzzled by this at first. I drained the 300-gallon tank that KRWA uses on these well-cleaning jobs and began filling it again. Since the well is in such close proximity to the lake I wondered if somehow lake water could be influencing the well water. The water looked clear coming out of the hose but in a large amount you could see the high turbidity.

Tasting the water indicated to me however that there was an iron problem and that the discoloration was due to reaction of chlorine with the iron in the water.

With that conclusion, Park Manager Reed Rolfs and I went back to the storage tank to begin the clean-up job. While draining the tank we could see some of the fluffy material as it ran across the concrete slab the tank sat on. The material was red-orange in color, again indicating heavy iron content. The fluffy form of the material told me that it was a by-product that forms when iron related bacteria is present. The tank was cleaned with a strong, 500 mg/l chlorine solution. This solution was allowed to sit in the tank and

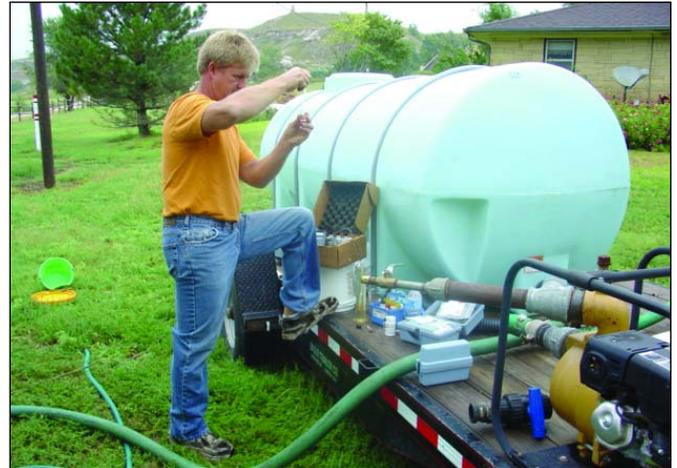
That evening, we mixed and pumped a 1,000-mg/l chlorine solution into the well. Talk about some stained water when that

KRWA Tech Jon Steele is shown checking water chemistry after the treatment solution was introduced and surged in the well.

much chlorine is added to water that has a high iron content! The water resembled tea. We allowed the solution to sit overnight. The next morning we surged the well by starting and stopping it to mix the solution more in the well; we also refreshed the process with more highly chlorinated water.

Another batch of the chlorine solution was introduced into the well for a total of 3,000 gallons of treatment. This was again allowed to sit overnight in the well and then surged again the next morning. In a clean up process, chlorine residuals should be monitored and adjusted after the solution has remained in the well after several hours. As the chlorine is working to destroy bacteria and break up the biofilms it is consumed and likely needs to be refreshed.
