# De Soto attacks water loss with reduction of nearly 350-gpm

*Gary Armentrout  
Technical Assistant*

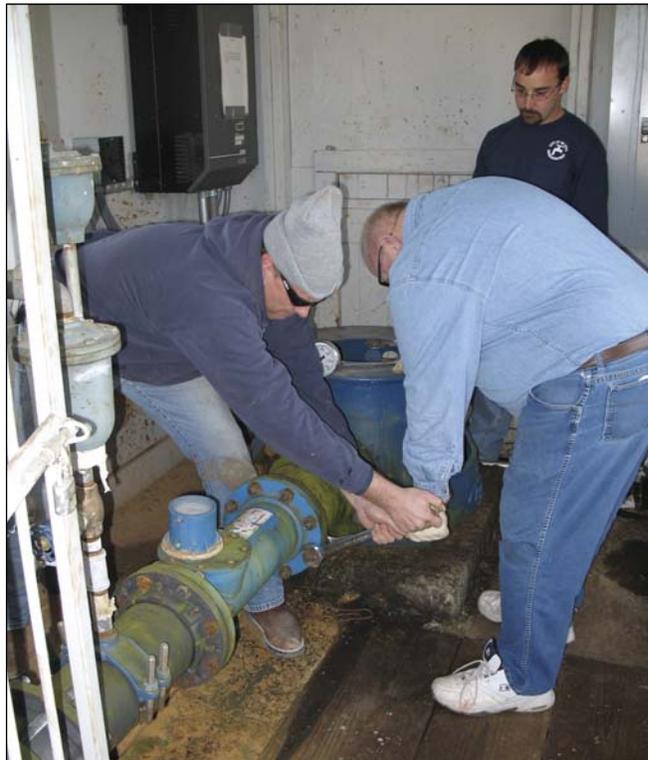
*Top: This image shows one of the new water meters that was installed at the city wellfield. The new master meters helped to correct the city's 'unaccounted for' water losses by more than 350 gpm.*

*Left: De Soto Water Department Superintendent Clarence Brunk and other members of the city water department begin to remove one of four old well meters; all were changed out.*

A review of the master meters on the KDHE list of approved meters for raw water revealed maybe one or two that could meet the city's conditions. Four of these were ordered and installed on the wells. They have performed as intended. It was revealing that the old meters were over-registering, one by as much as 300 gpm! This reduction in over-registering at the wells, coupled with line repairs at

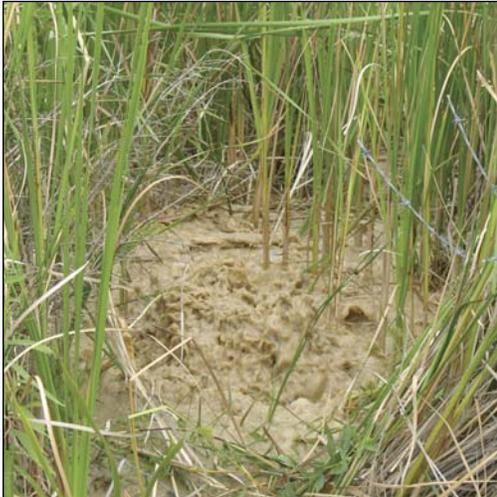
**Above:** An increase in line pressure can force a leak to the surface. On the water loss survey at De Soto, a mainline valve was fully opened increasing pressure from 25 to 76 psi. It brought the leak shown here to the surface.

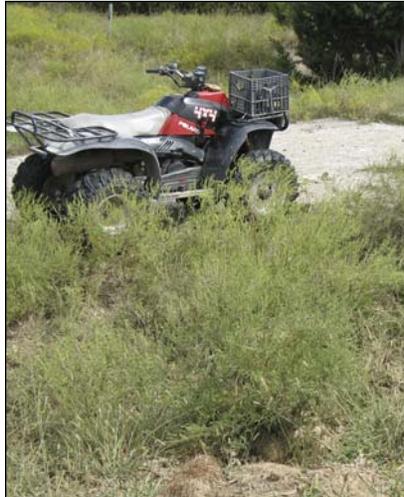
**Center:** The ATVs used in De Soto at the Sunflower Ammunition Plant water loss survey made searching a wide area much easier.

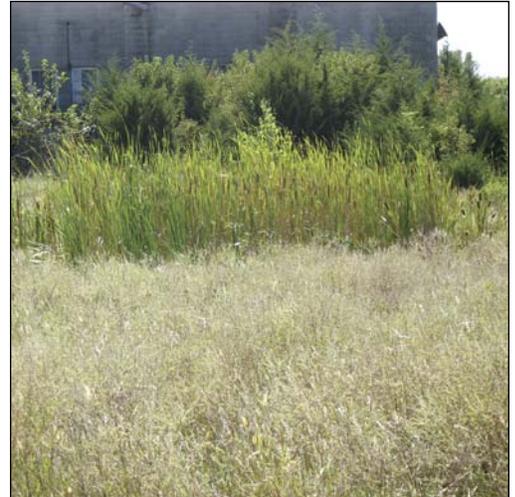
**Right:** A patch of cattails is a very good spot to check for water losses as this patch proved.

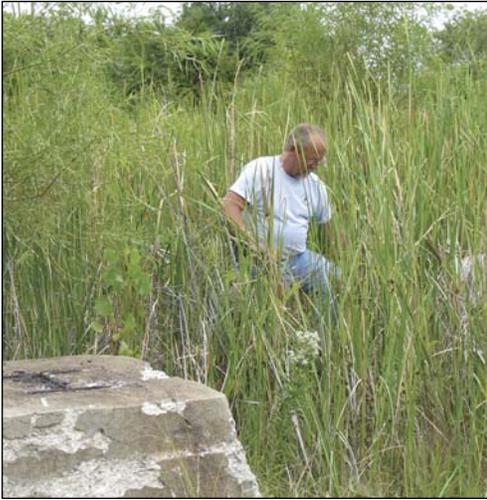
**Above:** De Soto Water Department Foreman Dennis Smith searches a patch of cattails for their source of water on the old Sunflower Ammunition Plant site.

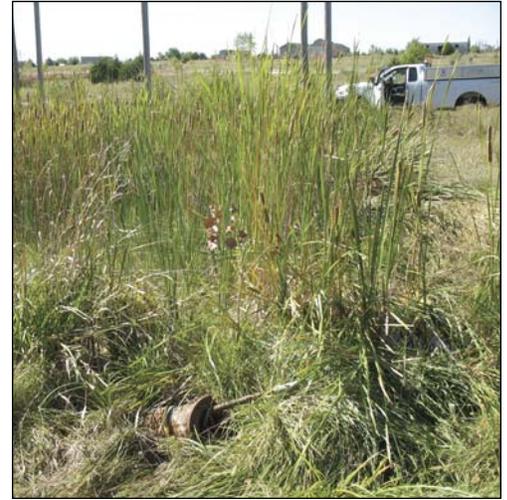
Jackson and I spent many days searching the vast ammo plant grounds afoot, by truck and ATV. The ATVs proved to be a great asset in locating the many leaks that we found. Numerous old buildings are being demolished with heavy equipment being used extensively. We found where a track hoe had run over a fire hydrant. This one mishap resulted in a loss of up to 80 gpm.

**Right:** Looking in this patch of cattails proved fruitful as it revealed what was left of a fire hydrant that had been run over by a track hoe.
