# KANSAS WATER SYSTEM CONTAMINATED DUE TO BIRDS ACCESSING STORAGE TANK

### An incident in Kansas, 2011

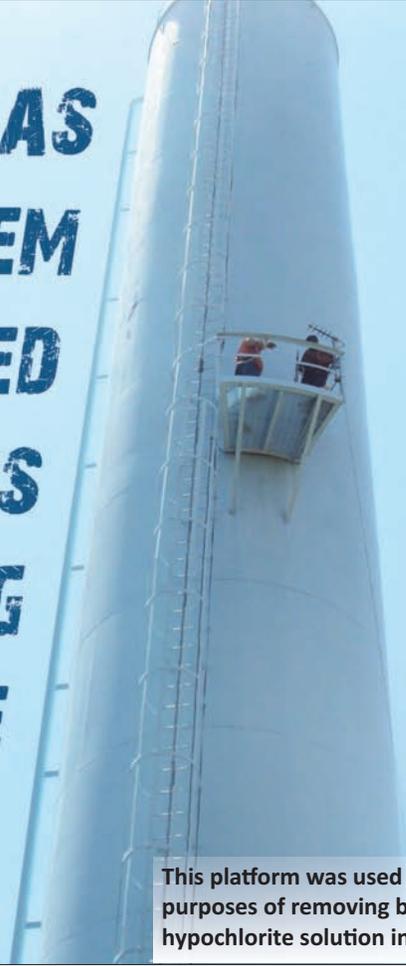
This platform was used to access inside of standpipe for purposes of removing bird carcasses and adding sodium hypochlorite solution in order to disinfect with free chlorine.

On July 12, KDHE and KRWA agreed that the standpipe had to be super-chlorinated to AWWA standards using free chlorine. The AWWA standard requires that a minimum 10 mg/L free residual remain after 24 hours of contact time. Calculations were made to determine how much sodium hypochlorite was needed to

reach breakpoint and still provide a free residual in the standpipe greater than 10 mg/L. This required adding fifteen gallons of 10 percent sodium hypochlorite and five gallons of six percent. The standpipe was then refilled, beginning the 24-hours contact time. The contact period ended on the afternoon of July 13. The residual in the standpipe was checked and met the

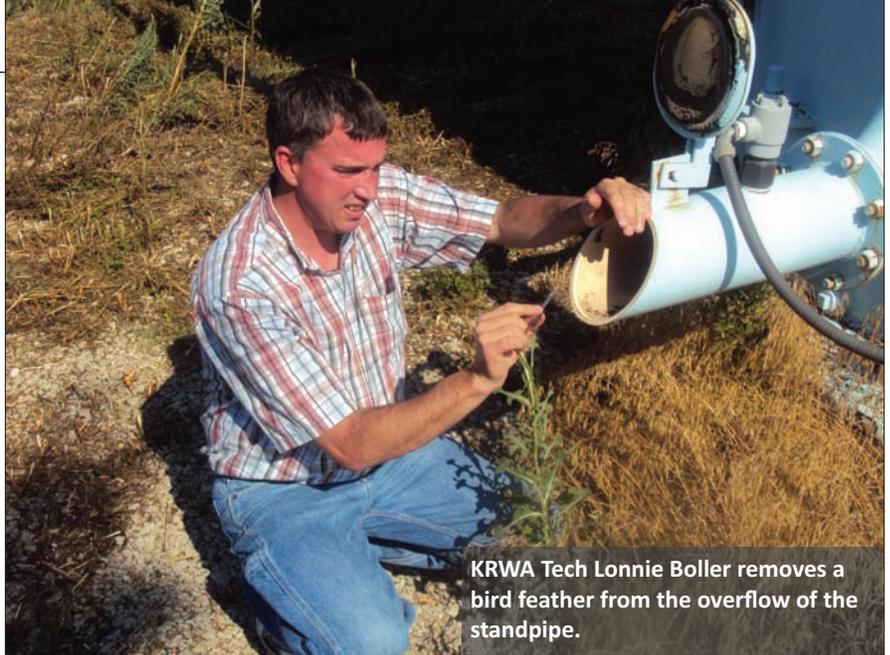
KRWA Tech Lonnie Boller removes a bird feather from the overflow of the standpipe.

system early on July 8. The 70,000-gallon standpipe was filled to overflow. Bird feathers, etc., were found at the overflow, confirming the standpipe as the source of the bird that was found at the water meter. The standpipe was immediately taken offline; chlorine residuals were checked throughout the distribution system. While residuals were above required levels, that still created concern, as they were combined – and not free chlorine. The

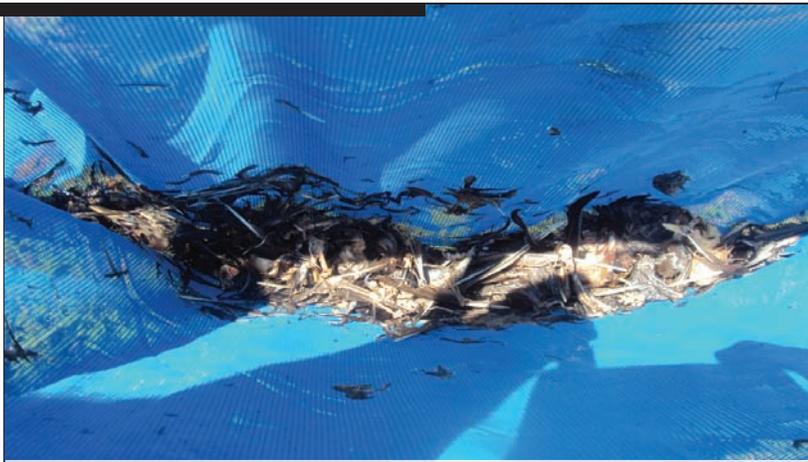
Feathers, bones and other body parts from approximately fifteen dead birds were found after draining the 70,000-gallon standpipe.

The standpipe was drained for cleaning and more bird carcasses were found. Parts of at least fifteen dead birds were eventually found. It was also discovered that a 2-inch port on top of the standpipe was open. The screw-in plug was setting on top of the standpipe next to the open port. The

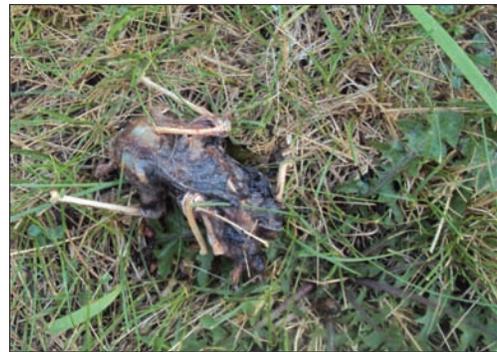
This photo shows decomposed bird carcasses flushed from fire hydrant adjacent to 70,000-standpipe.

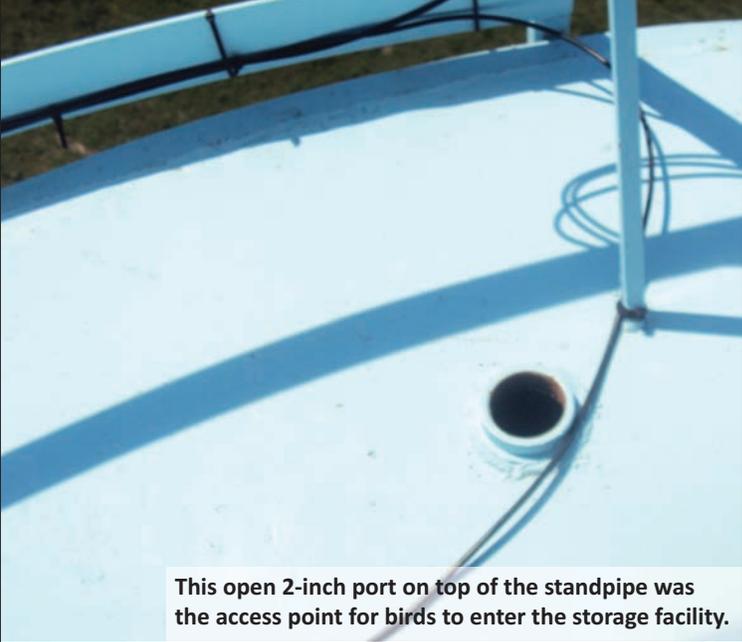
This open 2-inch port on top of the standpipe was the access point for birds to enter the storage facility.

open port was just large enough to allow birds to fly into the tower, but they were unable to escape. KRWA staff did their best to clean the tank and super-chlorinate by adding sodium hypochlorite, but refilling with water that had combined chlorine was not sufficient to kill all pathogens in the tower. The system's supplier also boosted the combined residual, but even that was not sufficient to kill pathogens. Retesting of water in the standpipe confirmed this fact. The boil water advisory remained in effect.

- All storage facilities must be routinely inspected, cleaned and repaired to ensure vectors cannot gain access. All vents and overflow pipes must be inspected to ensure they are adequately screened and that birds have not compromised such screens. Entry hatches should be inspected to ensure they are closed and locked to prevent vandalism/sabotage and limit liability. In the case of Gideon, Missouri, had the city had their 100,000-gallon tower inspected routinely, the waterborne disease outbreak may have never occurred. This also applies to the situation with the small water system in Kansas. It appears that the 2-inch port on top of the standpipe had been open for an extended period. Had the standpipe been routinely inspected, the deficiency would have surely been discovered and corrected.

- Make sure KDHE design standards are met. KDHE standards require all storage facility vents be screened to exclude birds, animals, insects, rain and dust.

Vents should be screened with 16-mesh, non-corrodible screen.
