# COLD WEATHER ADDS CHALLENGES TO WATER SYSTEM OPERATIONS

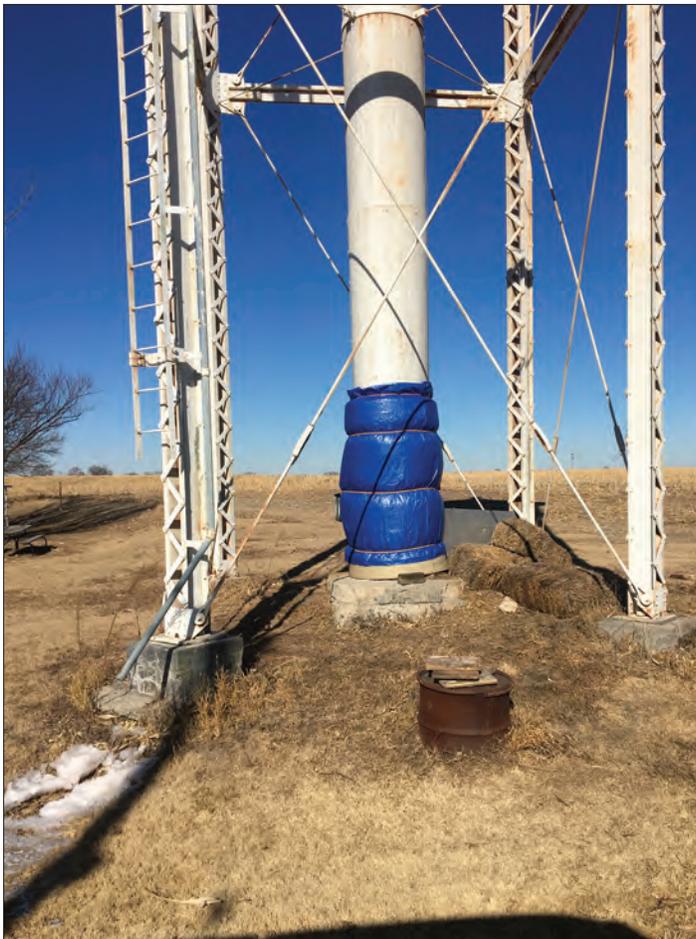
**One small town placed this blanket wrap around the base of the riser pipe. The interconnection to a neighboring rural water district is made above ground on the opposite side of the riser.**

After several days operating with high water loss the base of the stand pipe below the bowl thawed so that the interconnect to the neighboring rural water district was operable. I then transported and installed one of the KRWA pressure tanks. Doing so enabled the small town to take water directly from the water district at a rate of 20 gpm vs. the 91 that had been produced by the wells. After slightly more than a day of operating in that manner, the riser pipe of the city's storage tank thawed and became operable again.

After observing some of the heat tape installed on the interconnect I noticed it was double wrapped in one spot. That is a problem in that it cancels out the heat tape operating efficiently. Unless corrected, with wind chills well blow zero and because of the lack of insulation, the piping would freeze again.
