Assisting Water Systems in Puerto Rico

Locations of water systems visited to provide assistance with applications for funding.

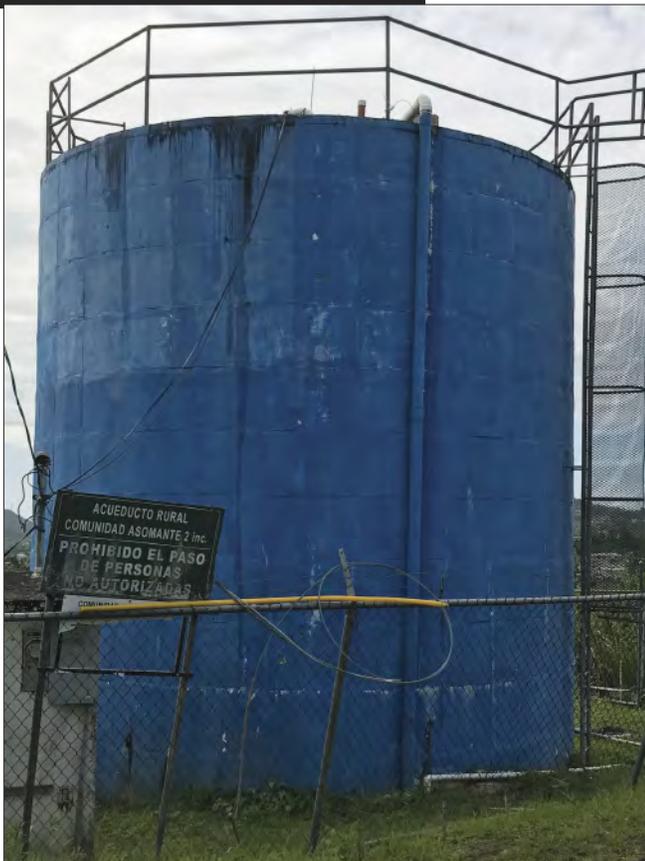
This photo shows the water storage tank for Comunidad Asomante, Seccion II, Inc. Las Piedras.

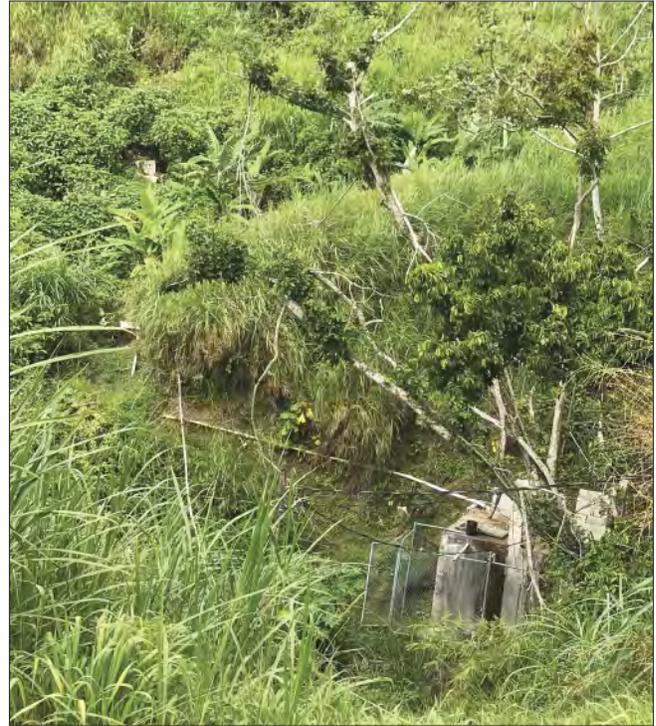
the operator is receiving “free” fuel from FEMA for the generator! Most of the water sources are either springs or wells. Storage tanks are made of concrete and system pressure is by gravity. A few of the water systems are metered. Many of the waterlines are pvc pipe laying on the ground because of the rugged, mountain terrain. The temperature only drops to the low 50’s or high 40’s so there is no concern for freezing pipelines. The water systems have no office buildings. They use either a local community center or operate from homes.

The rugged terrain causes pipes to be laid on top of the ground as for the water system for Eladio Andreu, Comeno, Puerto Rico.
